# LUG NUT WARNING!

by Bill Lancaster — Sunnyvale, California

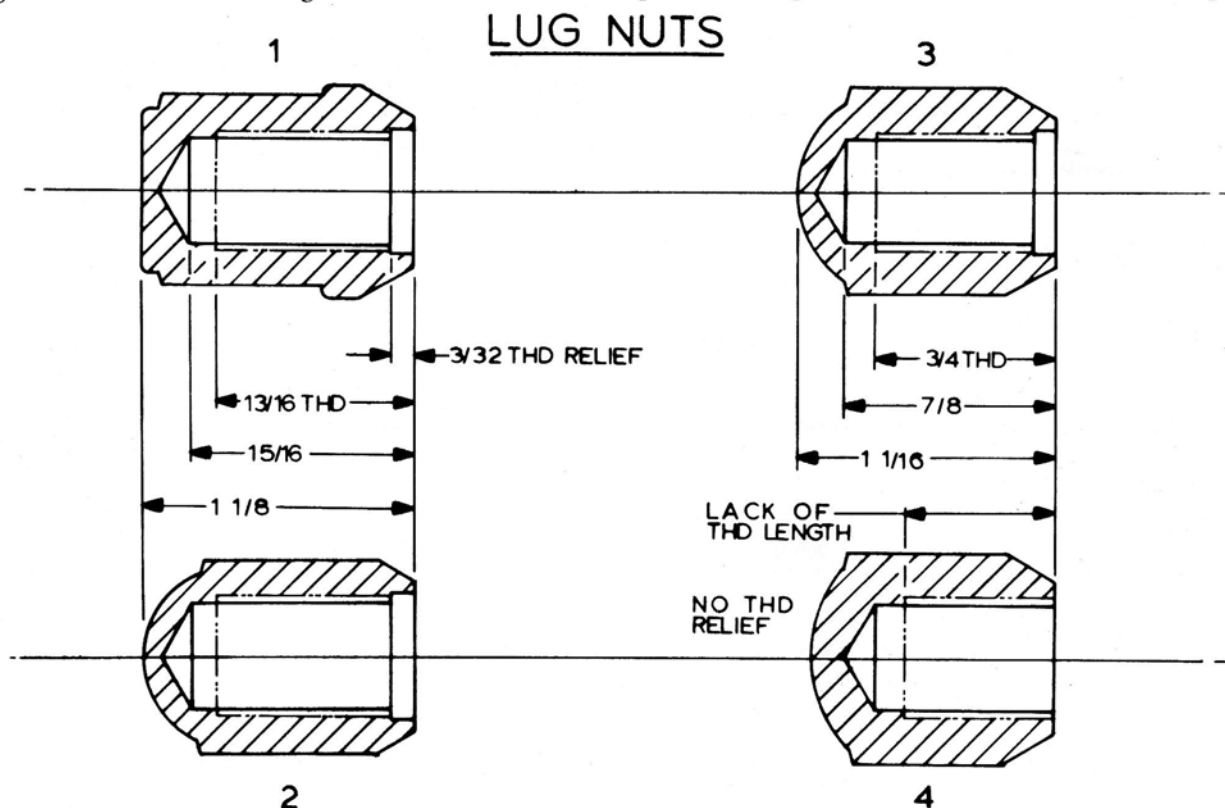
very hard to remove. They were found to have damaged the threads on the hub stud. Prior to using them, all the lug nuts and studs were chased. The threads were again chased, and the lug nut thread length was verified to be correct. This included tap drilling deeper to provide .75 inches of full thread on these three lug nuts. After driving a couple hundred more miles, the lug nuts were again hard to remove. After much frustrating analysis, it was determined that a thread relief exists in a normal lug nut that did not exist in these defective lug nuts!

The enclosed sketch shows these conditions. The first cross-section is the "AR" lug nut. The second is our best estimate of the 11/16" hex size lug nut used for a short time after the "AR" nut was replaced. Lug nut number three is the most common Model A lug nut. The fourth cross-section is the unacceptable reproduction lug nut, which lacks adequate thread depth and lead-in thread relief.

If you have reproduction lug nuts of the common type, check to see that they have the following characteristics:

1. The overall length must be at least 1-1/16 inches.
2. At the entrance, there must be no threads for the first 3/32nds of an inch.
3. The tap drill depth must be at least 7/8 inch, and
4. The full thread length must be at least 3/4 inch (which can be checked with a 1/2-20 UNF x 3/4" long bolt).
