# Steering Column Support

by Tom Endy

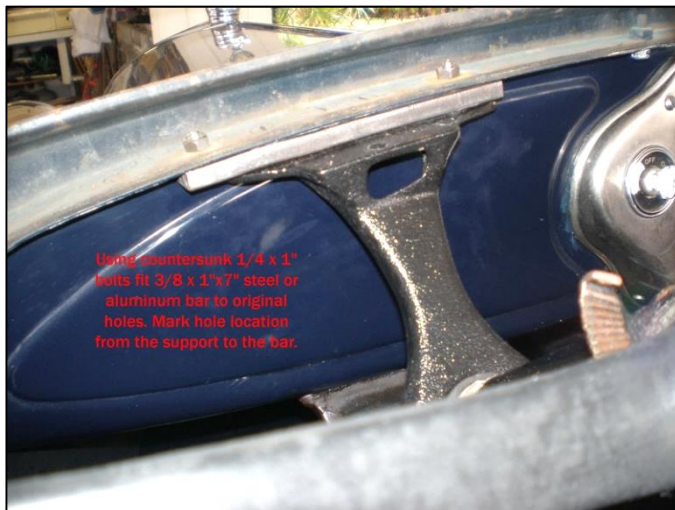
The following photos of the mounting assembly installed in a 28-29 car were obtained from a posting on the Fordbarn forum a few years ago.

The adapter can be fabricated from either steel or aluminum. It should be one inch wide, seven inches long, and 3/8 inches thick. Four holes are drilled in the adapter. Use four 1/4-20 countersunk bolts, one inch long, along with four nuts and lock washers.

Drill and mount the adapter to the dash rail as shown in the photo with two of the bolts. Mount the later column support to the steering column and mark the adapter where the mounting holes

line up. Drill the other two holes in the adapter. Mount the column support to the adapter using the other two bolts.
